**PROJECT MEMORANDUM**  
**SCE WEST OF DEVERS UPGRADE PROJECT**

**Date:** February 20, 2019  
**To:** John Forsythe, Project Manager, CPUC  
**From:** Vida Strong, Aspen Project Manager  
**Subject:** Monitoring Report #50: February 3 to February 9, 2019

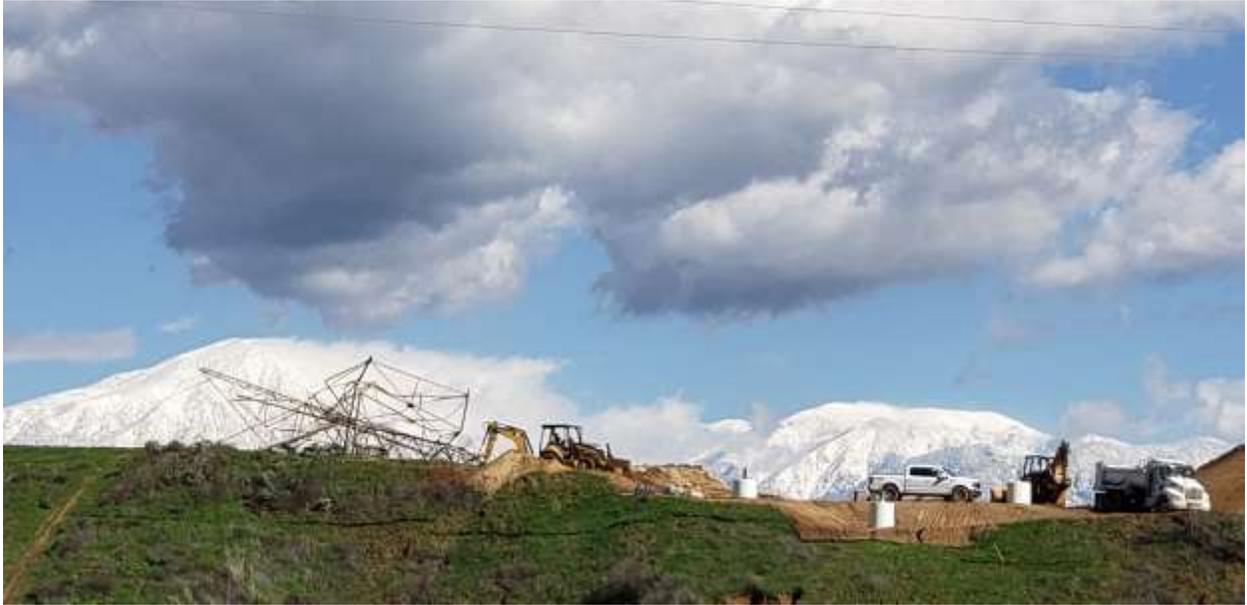
Photo 1 – Wreck-out of existing towers near Tower 3N39, Segment 3.

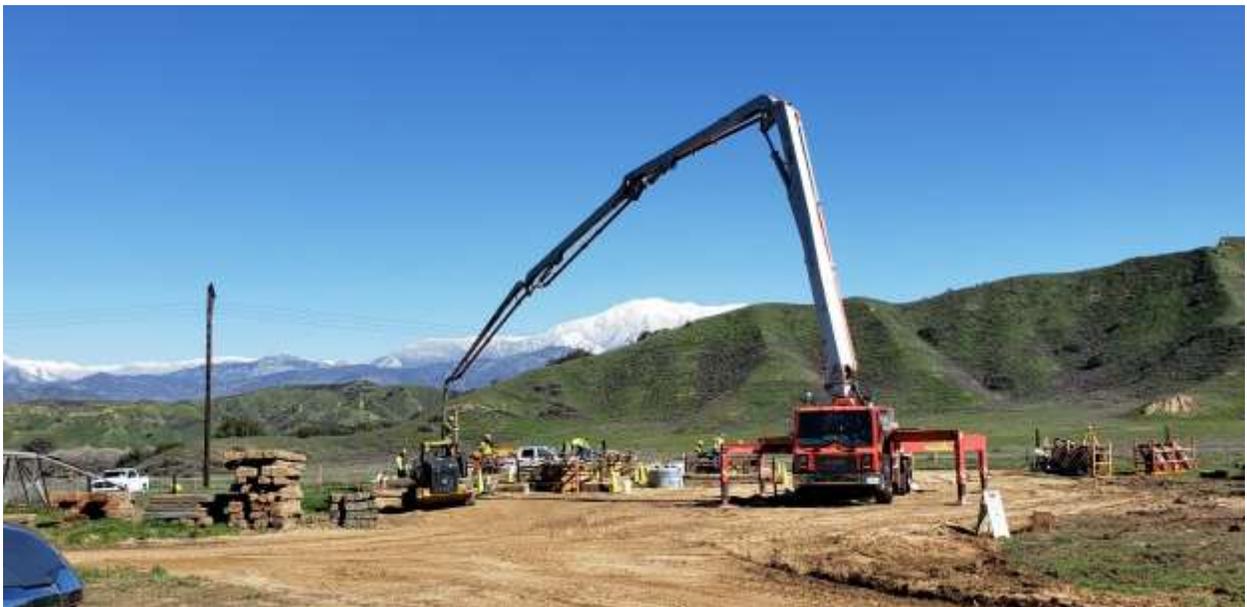
Photo 2 – Crews conducted foundation pouring at Tower 3N06, Segment 3.

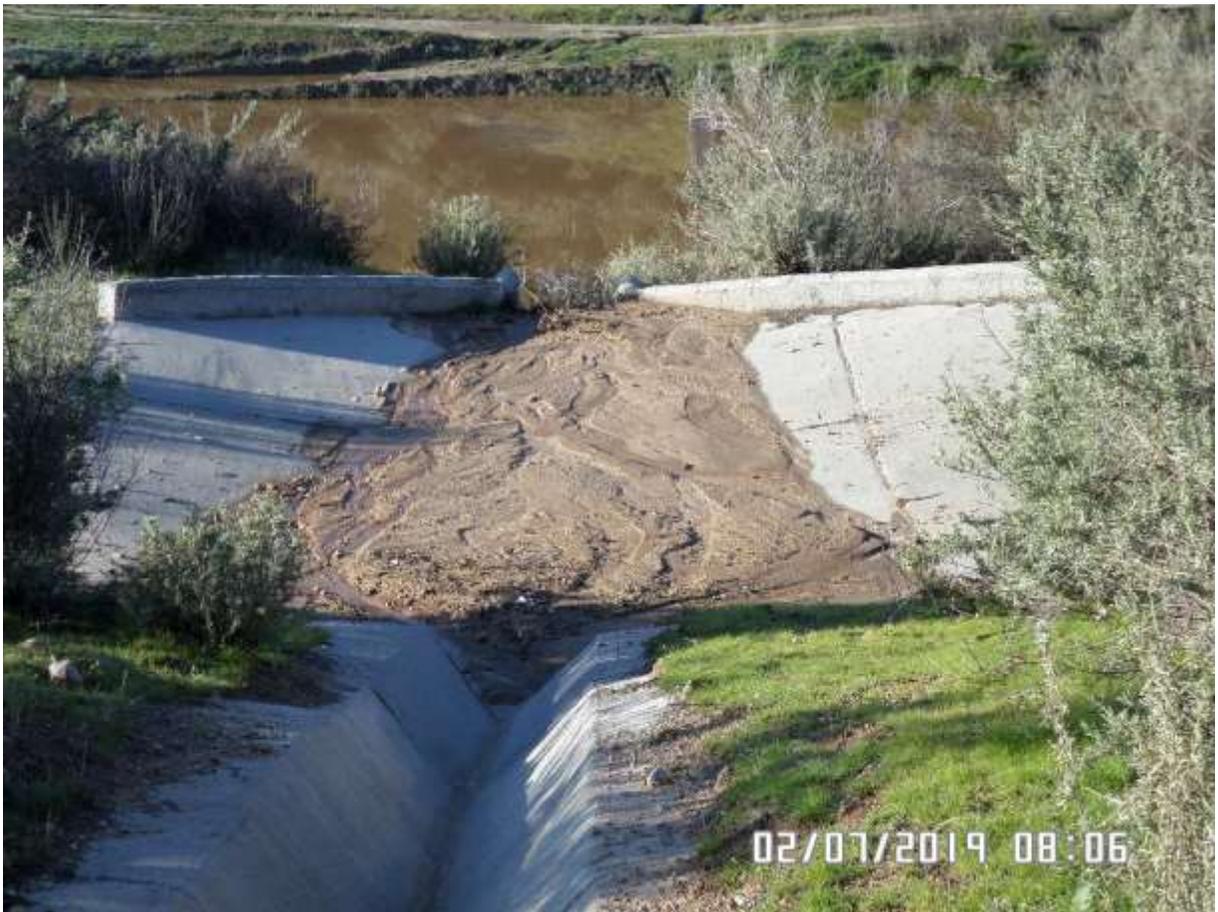
1. One SCE self-reported compliance incidents and no CPUC compliance incident were documented for construction activities associated with NTP #4 throughout the monitoring period. On February 07, evidence of erosion of soil from the access road south of Tower 3S55 into a v-ditch leading to a detention basin for the adjacent landfill (see Photo 3). The detention basin feature is mapped as a non-wetland jurisdictional drainage (3008).

Photo 3 – Offsite sedimentation into v-ditch leading to non-wetland jurisdictional feature #3008 near Site 3X55, Segment 3. Photo courtesy of SCE.

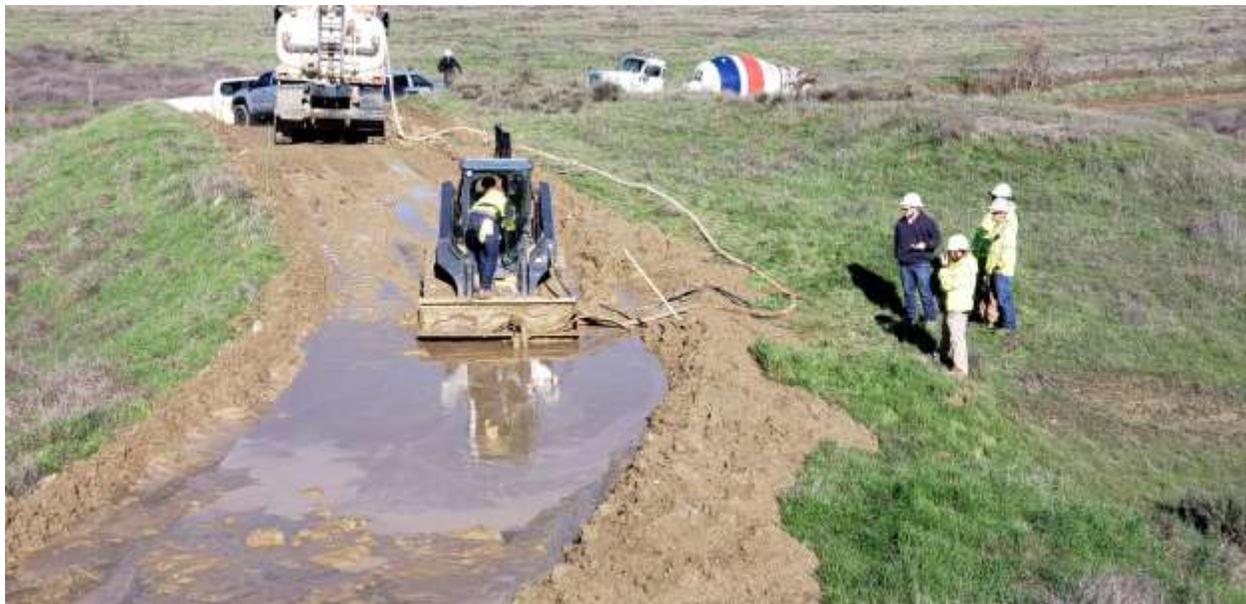
Photo 4 – Pumping of stormwater accumulated along access road to Site 3X03 in order to dry out the roadway and gain access to the tower site, Segment 3.

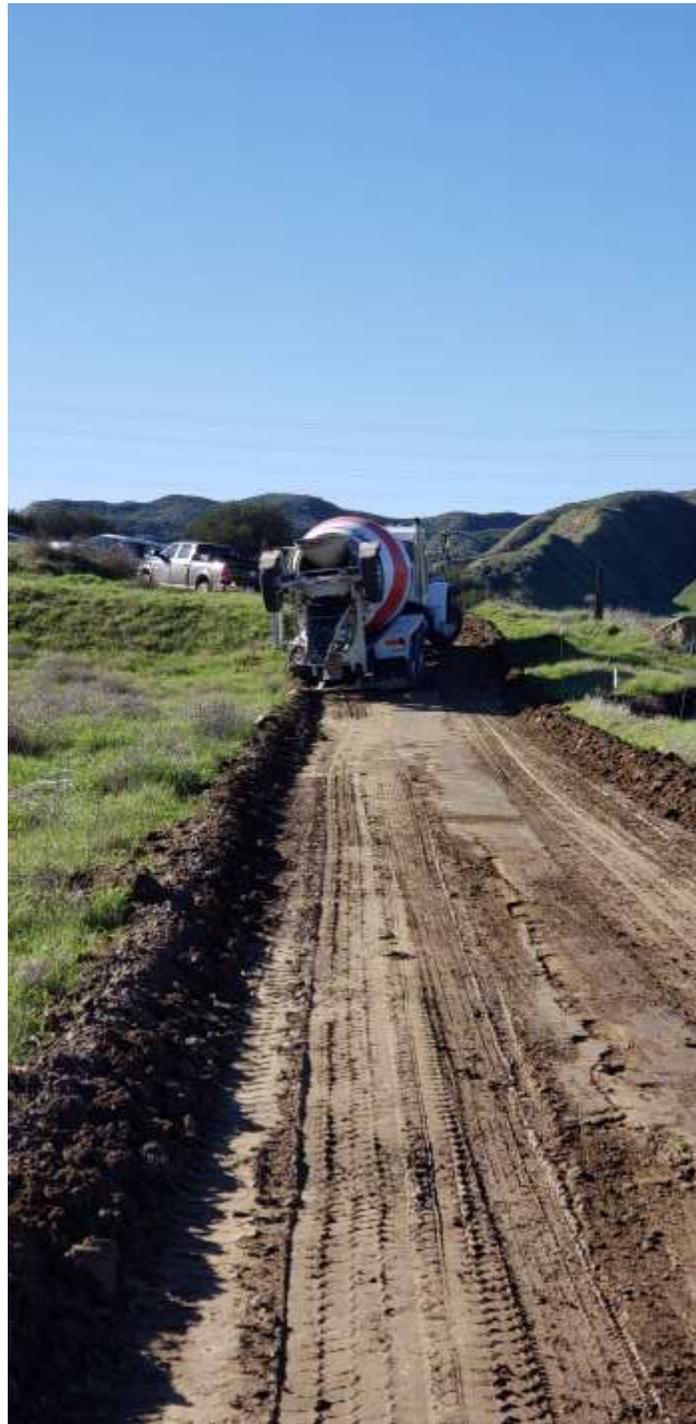
2. The CPUC EM noted that access road grading following recent rain events was occurring in various locations in Segment 3 and raised a concern that the new grading and associated berms could be modifying the natural drainage patterns. This concern was communicated to Project environmental staff. During the subject week, rainwater accumulated along the access road leading to Site 3X03 making it impassable. Crews pumped the water out of the puddle and continued with road grading to smooth out the road surface (see Photo 4). On February 7, a concrete truck traveling the access road to Site 3X06 slid slightly off the road becoming temporarily stuck (see Photo 5).

Photo 5 – A concrete truck became stuck while trying to access Site 3X06 during wet road conditions, Segment 3.

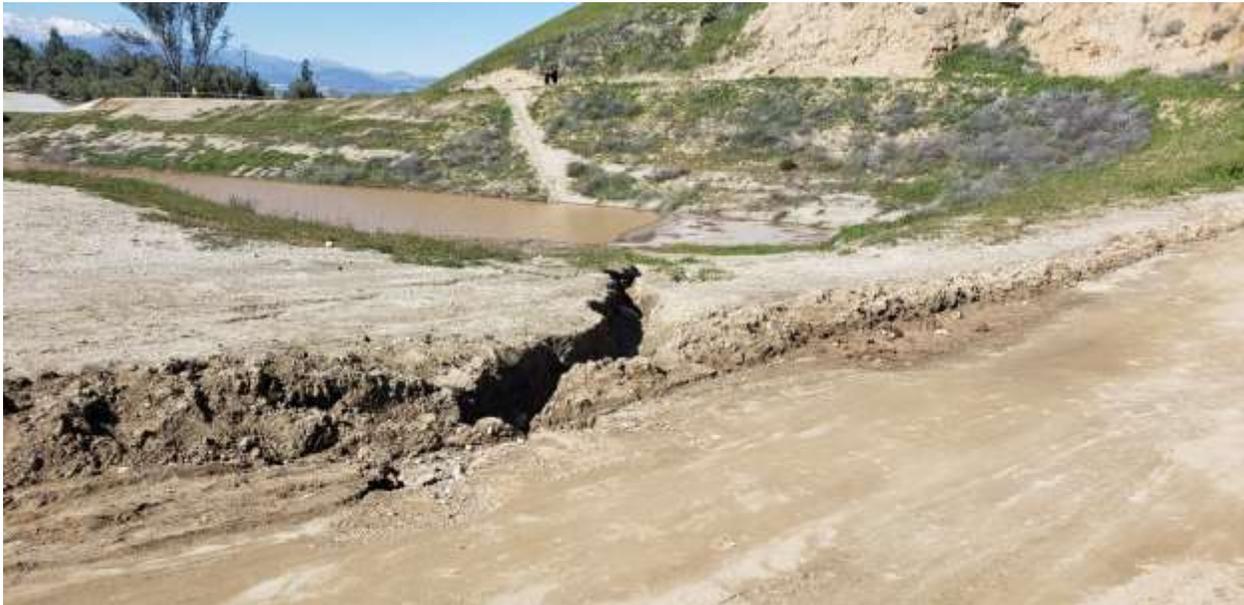
3. The CPUC EM noted that road maintenance had occurred along the access road at the top of Mountain View Road to Site 3X65 and it appeared that the grading had affected a defined drainage inlet to the basin (see Photo 6); however, the channel inlet portion of the drainage basin isn't currently mapped and avoided.

Photo 6 – The CPUC EM noted that road maintenance had occurred along the access road at the top of Mountain View Road to Site 3X65, Segment 3, and it appeared that the grading had affected a defined drainage inlet to the basin (JD ID #2085); however, the channel inlet portion of the drainage basin isn't currently mapped and avoided.

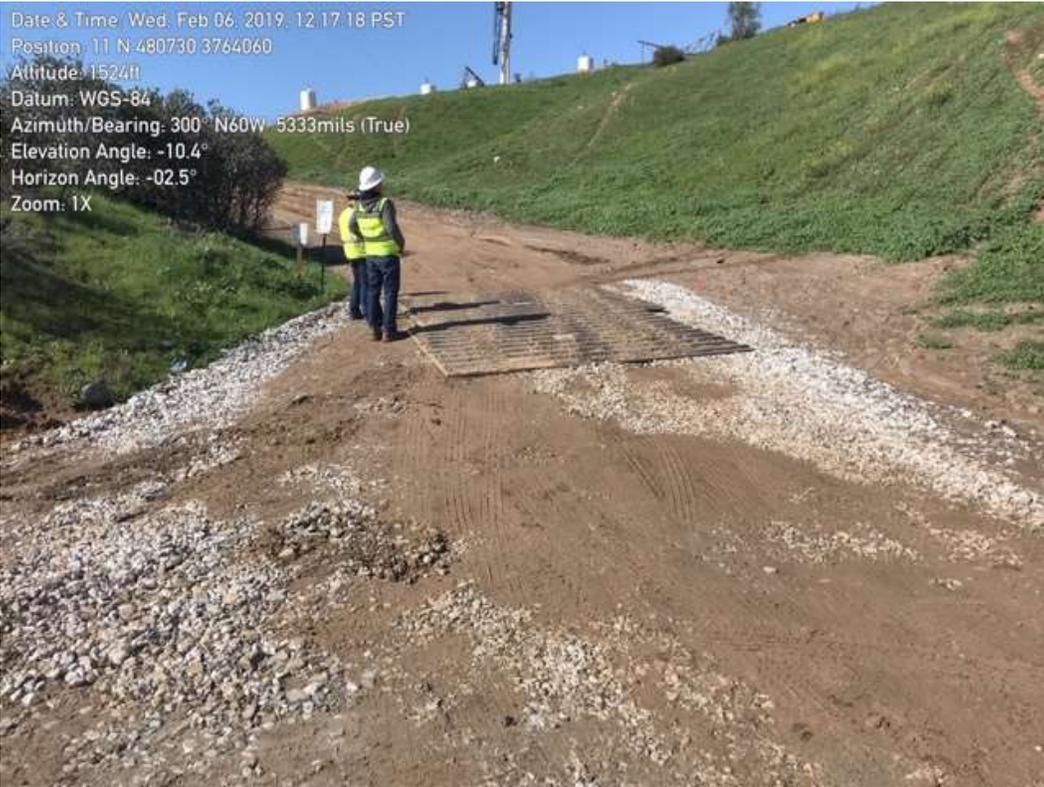
Photo 7 – Project QSPs noted that tracking controls were in need of maintenance near Site 3X55, Segment 3. Additional rock was delivered and the shaker plates were swept. Photo courtesy of SCE.

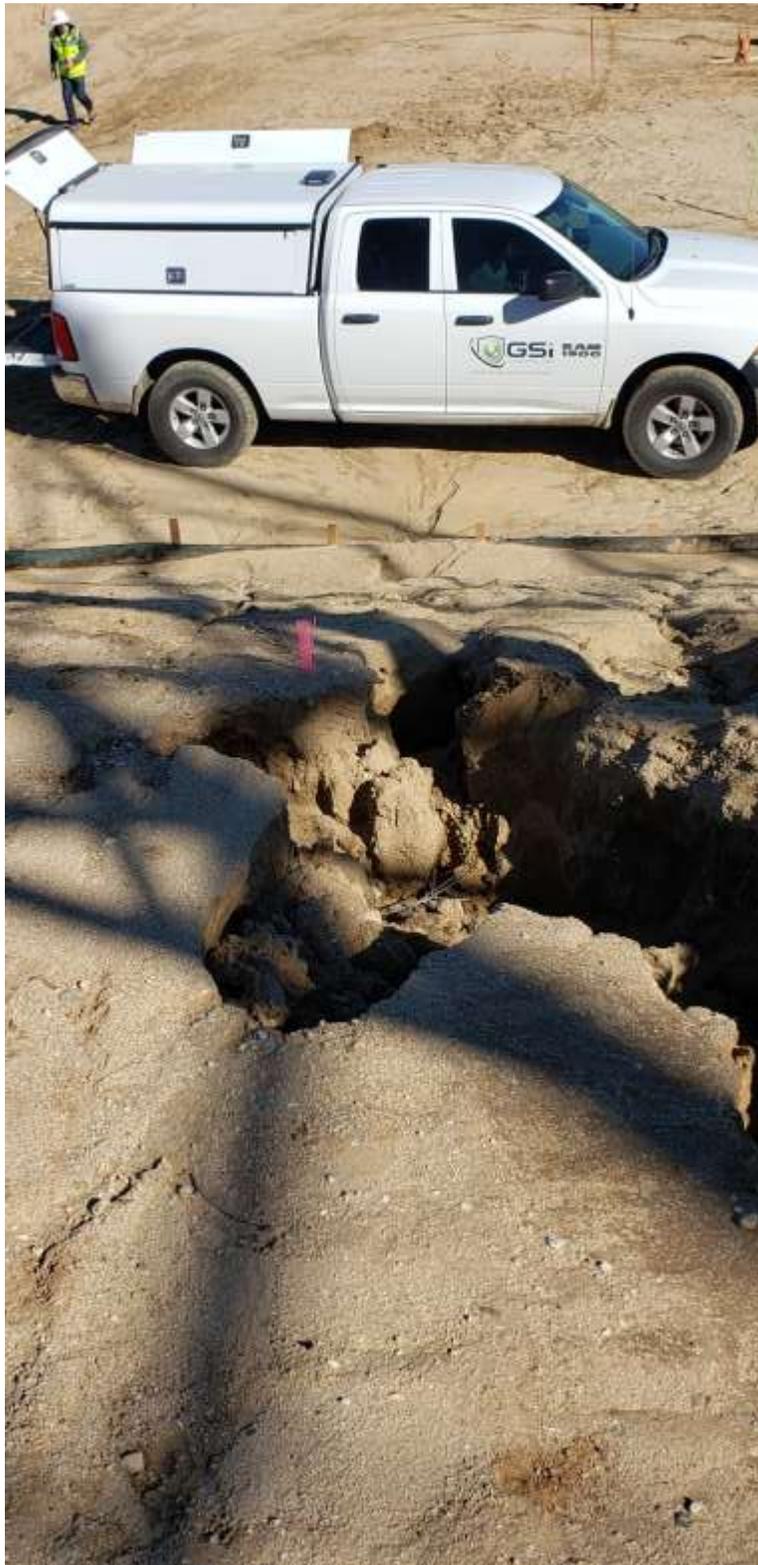
Photo 8 – Recent rains created gullying at Tower 3N63,  
Segment 3.
